**Flood Control Project Maintenance
Levee Inspections**

Fall 2012 Levee Maintenance Deficiency Summary Report

Sacramento River Basin

Sacramento Maintenance Yard Sacramento Bypass

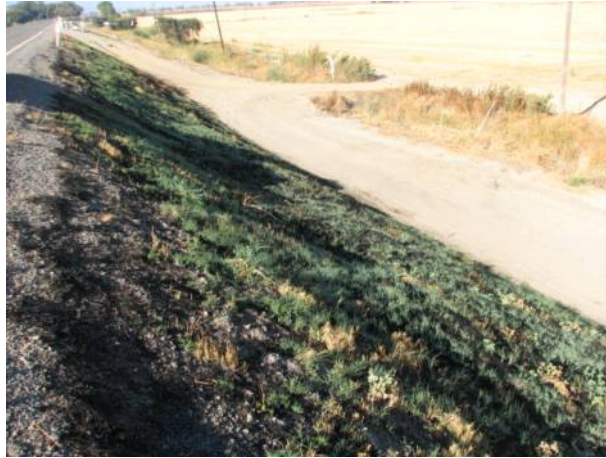
Levee Mile Report Line	2
Start Levee Mile	0.46
End Levee Mile	0.46
Location	Land Side
Category	Earthen Levee
Item	Slope Stability
Bulge at the toe of the levee slope. Photo fall 2012.	
johngw_f_20121015_741.jpg

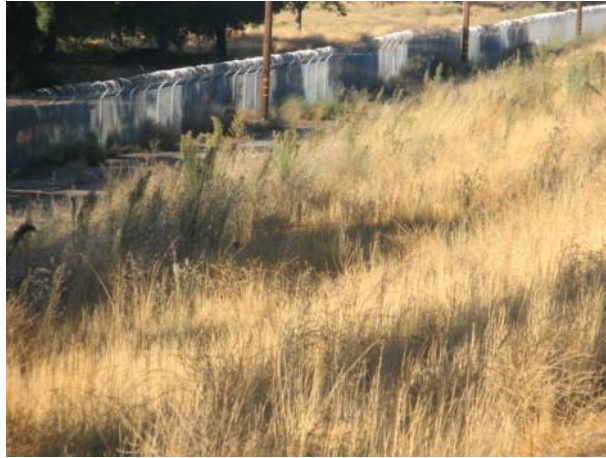
Levee Mile Report Line	4
Start Levee Mile	0.09
End Levee Mile	1.07
Location	Land Side
Category	Earthen Levee
Item	Vegetation
Grasses on the landside toe taller than 12 inches. Photo fall 2012	
johngw_f_20121015_737.jpg
